**CARACTERIZAÇÃO CONSTRUTIVA E MECÂNICA
DE PAREDES DE ALVENARIA DE ADOBE DE
EDIFÍCIOS EXISTENTES**

**CONSTRUCTIVE AND MECHANICAL
CHARACTERISATION OF ADOBE MASONRY
WALLS OF EXISTING BUILDINGS**

Tese apresentada à Universidade de Aveiro para cumprimento dos requisitos necessários à obtenção do grau de Doutor em Engenharia Civil, realizada sob a orientação científica do Prof. Doutor Aníbal Guimarães da Costa, Professor Catedrático do Departamento de Engenharia Civil da Universidade de Aveiro, e coorientação do Prof. Doutor Humberto Salazar Amorim Varum, Professor Catedrático do Departamento de Engenharia Civil da Faculdade de Engenharia da Universidade do Porto.

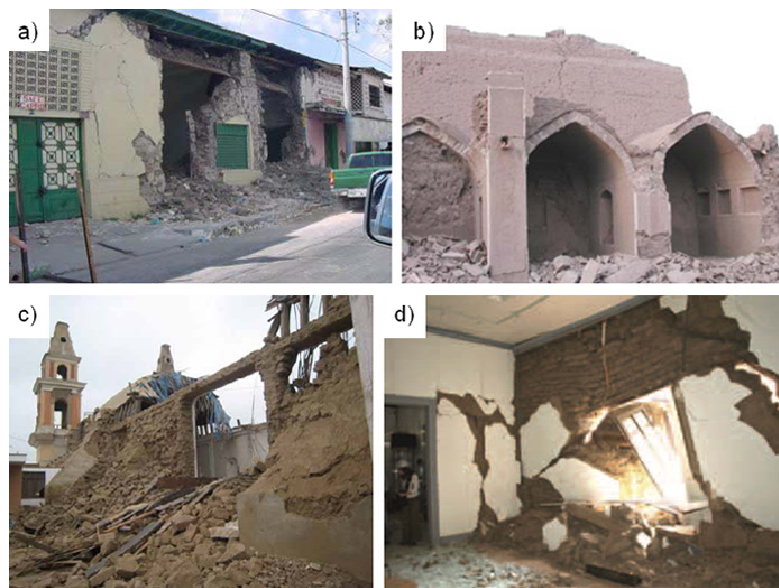
Figure 1.4: Damage on adobe buildings caused by the earthquakes that occurred in: a) El Salvador, in 2001 (JSCE 2001); b) Iran, in 2003 (EERI 2004); c) Peru, in 2007 (Blondet 2008); d) Chile, in 2010 (Contreras et al. 2011).

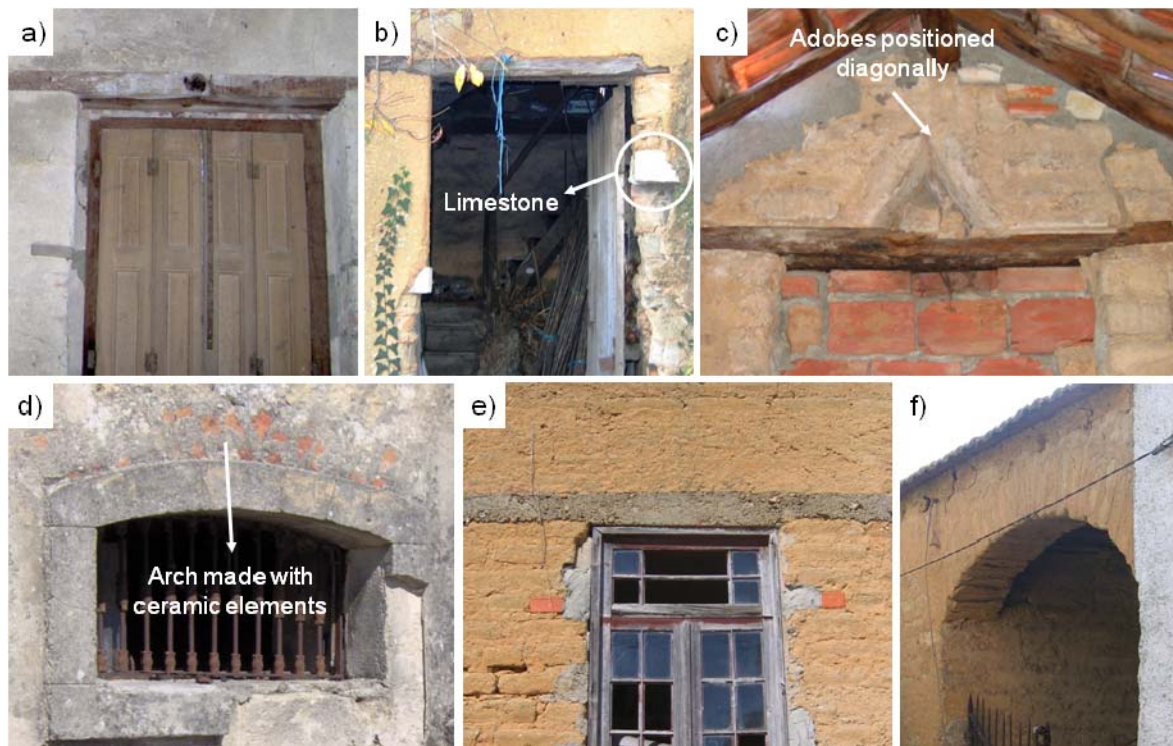
Figure 2.5: Structural system of facade wall openings.

It was possible to observe the structure of the facade wall openings in eight out of the total of twenty-one buildings studied (i.e. in 38% of the buildings). The common solution consists of a wooden lintel positioned above the opening with its ends embedded in the adobe masonry (Figures 2.5a, 2.5b, and 2.5c). In some cases, other reinforcing elements, such as small ceramic elements or stones, were added sparsely to the masonry adjacent to the sides of the openings (Figure 2.5b). In two buildings, the wooden lintel is combined with other elements:

- i) In building ‘H24’, in Anadia municipality, two adobe bricks are positioned diagonally above the wooden lintel, forming a triangle (Figure 2.5c);
- ii) In building ‘H28’, in Murtosa municipality, an arch made with ceramic elements is located above the wooden lintel (Figure 2.5d); in this building the wooden lintel extends along the perimeter of the building.

In buildings ‘H23’ and ‘H27’, located in Anadia municipality, in place of the wooden lintel there is a reinforced concrete beam that runs along the perimeter of the building

(Figure 2.5e). In building ‘H27’, the openings are sometimes laterally reinforced with cement mortar.

Five buildings have a small number of wide openings built with arches. In four buildings the arches are made with adobe bricks (Figure 2.5f) (in one case combined with a wooden lintel), and in one building the arch is made with small solid ceramic bricks.

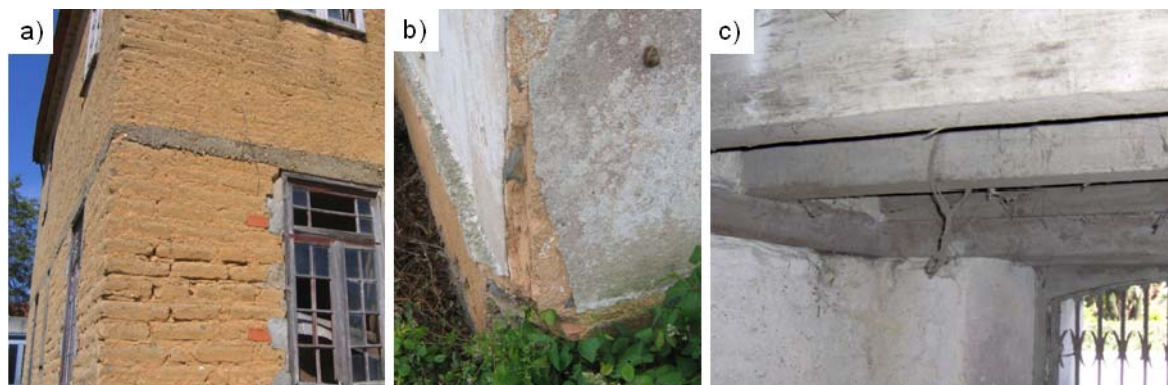
Figure 2.6: Connection between facade walls.

It was possible to observe the connection between facade walls in thirteen out of the total of twenty-one buildings (i.e. in 62% of the buildings). In these buildings, the connection between facade walls is made by the interlocking of adobe bricks in the corners (Figure 2.6a). In a few cases, small ceramic bricks or stones are sparsely distributed in the corners for additional reinforcement (Figure 2.6b). In a few cases, small ceramic bricks or stones are sparsely distributed in the corners for additional reinforcement (Figure 2.6b).

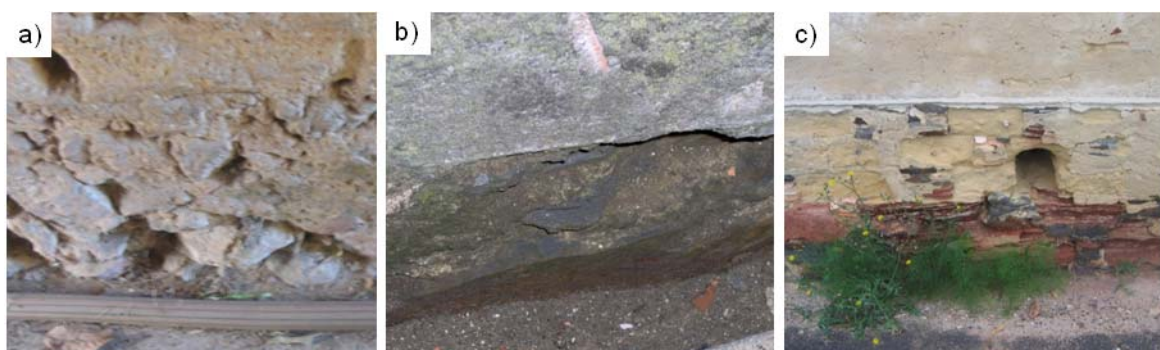
The stone foundations observed rise to a height above the ground level ranging approximately from 0.20 m to 0.80 m. The stones are irregular, with varied sizes and shapes, and are generally bonded with an earth mortar (with or without lime). In buildings ‘H21’, ‘H22’, and ‘H25’, in Anadia municipality, the foundations were made with limestone (Figure 2.7a); in building ‘H33’, in Murtosa municipality, schist was used

(Figure 2.7b); and in building ‘H34’, in Murtosa municipality, a combination of schist and red sandstone (‘Eirol stone’) was adopted (Figure 2.7c). Given that ‘mud adobes’ degrade very easily in contact with water, buildings with facade walls made with ‘mud adobes’ (described in subsection 2.4.3), such as ‘H33’ and ‘H34’, in Murtosa municipality, required the use of stone or ‘lime adobe’ foundations.

Figure 2.7: Types of stone observed in the foundation of facade walls: a) limestone; b) schist; c) schist and red sandstone.

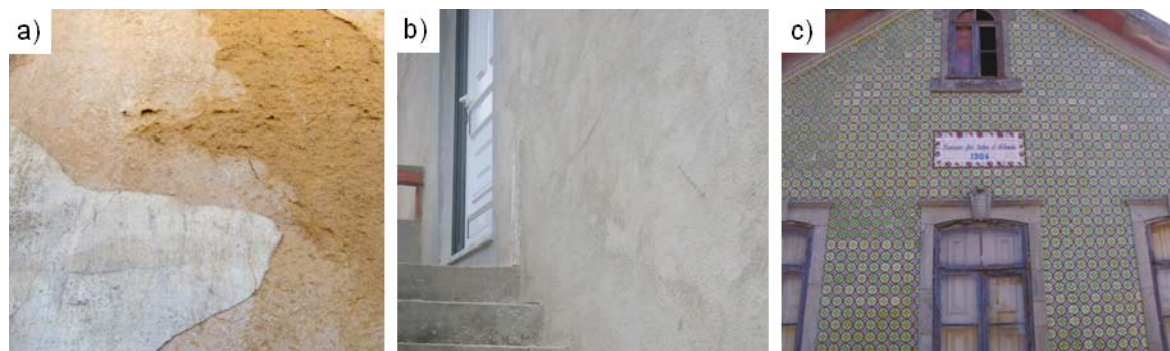
The different types of wall finishing solutions observed on the outer surface of the facade walls are presented in Figure 2.8. The facade walls of the majority of the buildings (62%) are rendered with lime mortar (Figure 2.9a). This was the solution traditionally used in the adobe buildings of Aveiro district. In some of these buildings, cement mortar was later applied in small areas of the wall to cover existing lime mortar deterioration. In 33% of the buildings studied, the facade walls are entirely coated with a more recent layer of cement mortar, normally applied over the existing layer of lime mortar (Figure 2.9b).

Figure 2.9: Exterior wall finishing solutions: a) lime render and lime paint; b) cement render; c) ceramic tiles.

The facade walls of 38% of the buildings studied are finished with lime paint (applied over the lime render) (Figure 2.9a), which was a solution traditionally used in the adobe buildings of Aveiro district. Other types of paint, which are now commonly used and generally have impermeable characteristics, were observed in 24% of the buildings. These different types of paint were added later, sometimes directly over the existing layers of lime paint. In building ‘H27’, located in Anadia municipality, the walls were not rendered. In building ‘H21’, also in Anadia Municipality, the facade walls were rendered but not painted.

Ceramic tiles, which were also a finishing solution traditionally used in Aveiro district, were observed in the facade walls of two buildings located in Murtosa municipality and four buildings in Aveiro municipality (i.e. in 29% of the buildings studied) (Figure 2.9c). Tiles were applied over the lime render layer and were generally used in the facade walls that could be observed from the street. In the buildings of Aveiro municipality, in particular, ceramic tiles are only used in the main facades. In these buildings, the walls that are not finished with tiles are finished either with lime paint or with a more recent layer of a different type of paint.

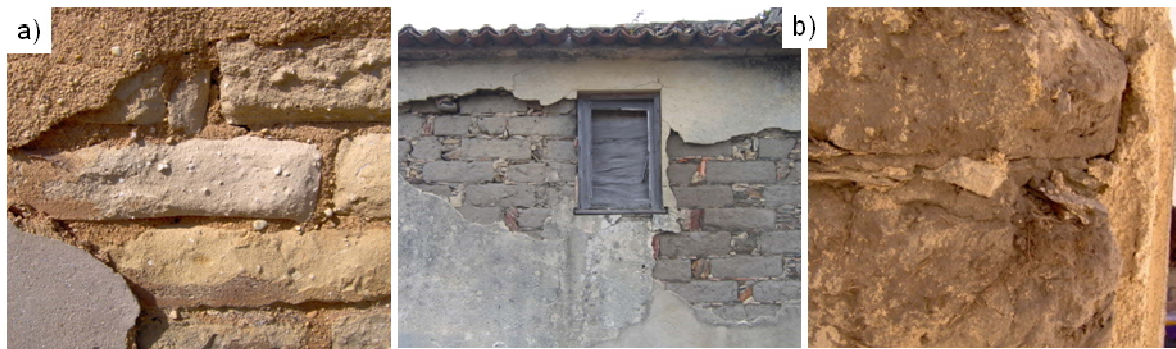
Figure 2.10: Traditional masonry materials.

The great majority of the buildings studied (eighteen out of a total of twenty-one buildings, i.e. 86%) have facade walls made with ‘lime adobes’ (Figure 2.10a). Two buildings (‘H33’ and ‘H34’) have facade walls made with ‘mud adobes’ (Figure 2.10b), and in one building (‘H26’) a combination of both types of adobes was used. As explained in Chapter 1, in Aveiro district, at an early stage, adobes were made with clayey soil (‘mud adobes’), sometimes with the addition of natural fibres, such as straw (Oliveira and Galhano 1992; Santiago 2007). From the middle of the 19th century, adobes stabilised with lime (‘lime adobes’) progressively became the solution commonly used. These adobes were made with arenaceous soil with a small silt-clay fraction (Santiago 2007) and air-lime in a percentage that normally ranged between 25% and 40% (Teixeira and Belém 1998). Local materials were used in the production of both types of adobes.

The mortar used in the joints of the ‘mud adobe’ facade walls under study has a similar composition to that of the adobes (i.e. it is made with clayey soil) (Figure 2.10b).

The traditional mortar used for renders and plasters, in this type of wall, is made with arenaceous soil and air-lime (Figure 2.10b). The mortar used in the ‘lime adobe’ walls – for joints, plasters, and renders – is also made with arenaceous soil and air-lime (Figure 2.10a). In some buildings, the render consists of just one layer of mortar with composition similar to that of the lime adobes. In other buildings, it includes one or two additional thinner layers of mortar made with finer sand and a greater percentage of lime.

In buildings ‘H33’ and ‘H34’, both with ‘mud adobe’ facade walls, small pieces of stone or ceramic material were also used in the joints (Figure 2.10b), contributing to increase the strength of the walls and the adhesion of the render to the walls. The vertical joints in building ‘H34’, in particular, are filled with pieces of stone and ceramic material and are approximately 0.10 m thick. Since this large thickness value is an exception, it was not considered in the analysis presented in Table 2.8.
